# Resolution of micropitting in case-carburized helical gear pairs through tooth profile modification

Article

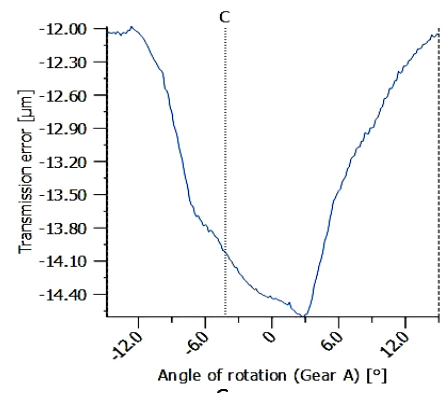
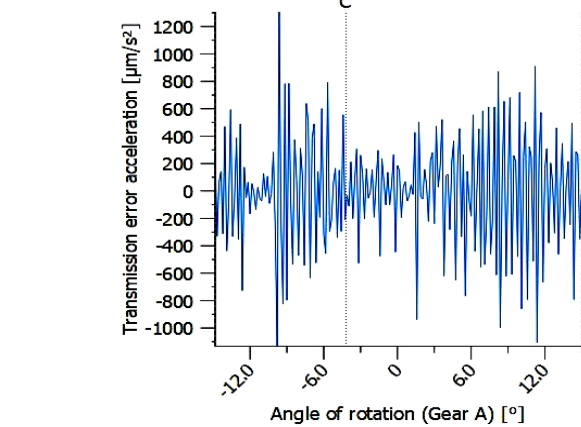
**Figure 7** Transmission Error Pre modification

There is a slight improvement in the transmission error over the rotation of pinion is observed. Transmission error looks to be shifted towards the pitch point and trying to maintain the equilibrium rather than being concentrated in one zone. However, it is not completely resolved. Post modification there is slight uprise in magnitude at the end and start of contact of pinion, but it is marginal and has no counter effect. Acceleration graph shows clear shift of error in the addendum zone as compared to dedendum zone of pinion. The maximum magnitude of acceleration is however showing same as peak point in both pre and post modification.

Figure 7 and Figure 8 shows the effect of transmission error of the gear pair pre and post modification.

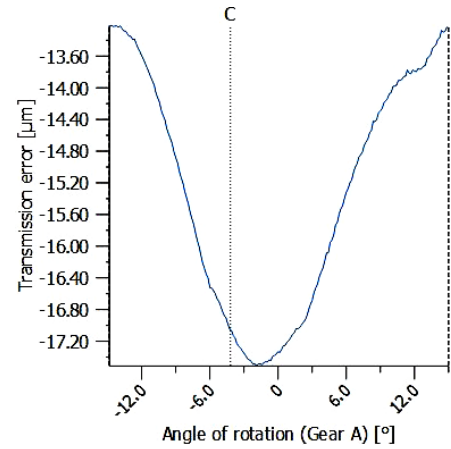
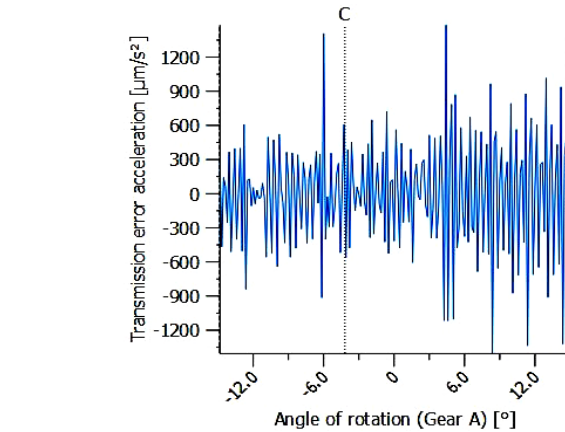
**Figure 8** Transmission Error Post modification

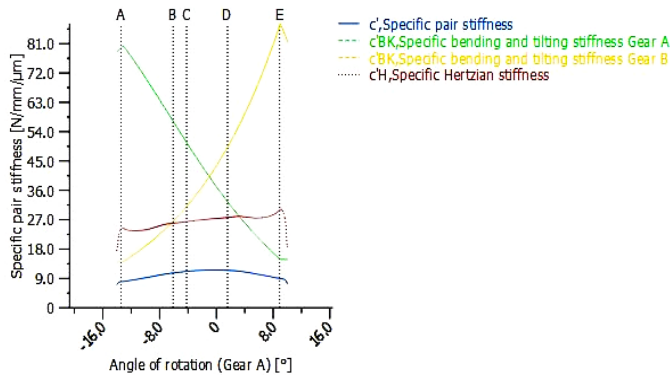
Figure 9 Single contact stiffness value pre modification

From the above shown Figures specific pair stiffness has improved in post modification stage as compared to pre modification stage. Tilting stiffness value has gone down as the maximum load is applicable at the centre of tooth in modified version as compared to unmodified version. Other parameters are also showing substantial improvement.

Figure 9 and Figure 10 shows the difference in the single contact stiffness value of gear pair pre and post modification.

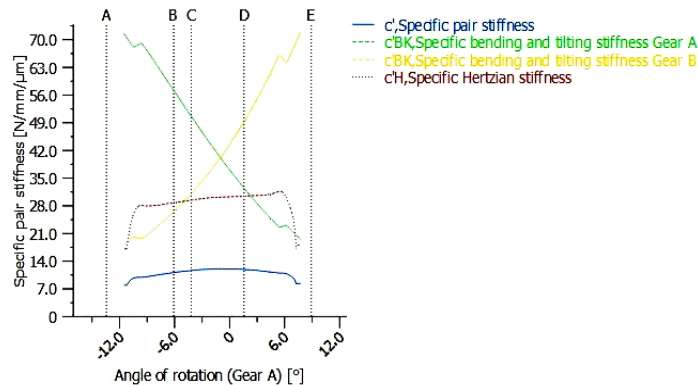
Figure 10 Single contact stiffness value post modification

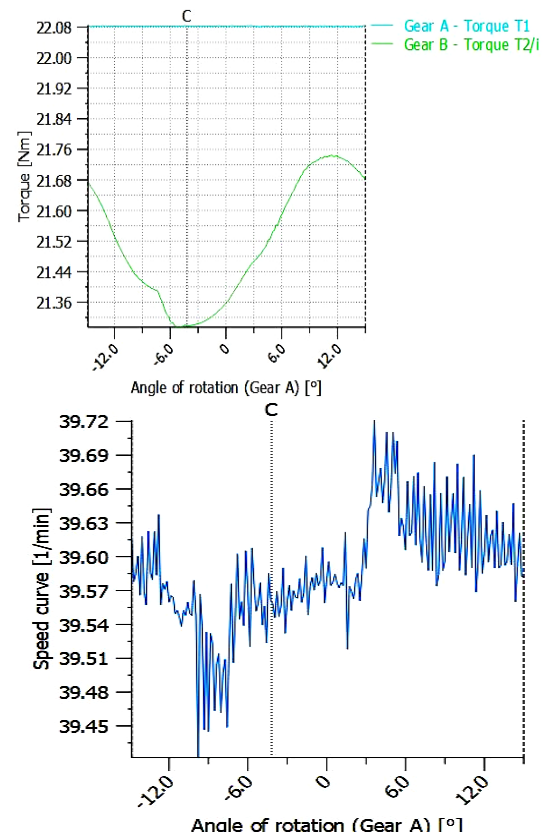
Figure 11 Torque and Speed curve Pre modification

Torque Curve in Pre modified pinion is much steeper than what it is shown in post modified condition. Sudden decrease in or increase in speed brings sliding speed also in picture. This nature of speed change cannot be eliminated however can be improved as it is totally dependent on the geometry of revolution and varying radius of curvature throughout the flank. This behaviour can be easily viewed in the Speed curve where the curve is not smooth line but a curvy line with many peaks which shows huge variation of speed over the angle of rotation. Both Torque and speed curve has improved in the dedendum zone. The addendum zone is more or less similar in both pre and post modified condition. Both Torque and speed peaks have increased in the post modified condition of gear pair.

Figure 11 and Figure 12 shows the Torque and speed curve of the gear pair in pre modified condition and post modified condition.

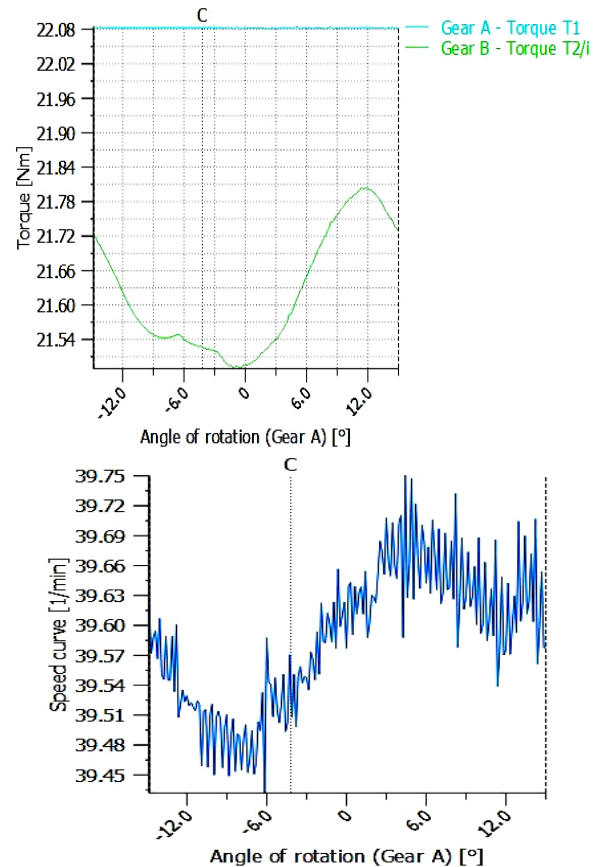
Figure 12 Torque and Speed Curve Post modification

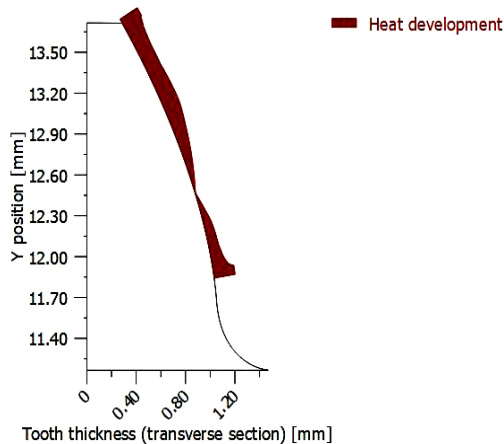
**Figure 13** Contact Temperature Pre modification

From Figure 13 and Figure 14 it is clear that the maximum temperature value has remained same. The occurrence of the contact temperature has changed with respect to the rotation angle. Because of the tooth modification the start and end of the contact has reduced. Same parameter is also depicted on the pinion tooth view where the temperature pattern is shown on flank line. This is moving the start of point of contact away from the tip of mating gear where there was very high friction.

Figure 13 and Figure 14 shows the contact temperature distribution in gears while meshing.

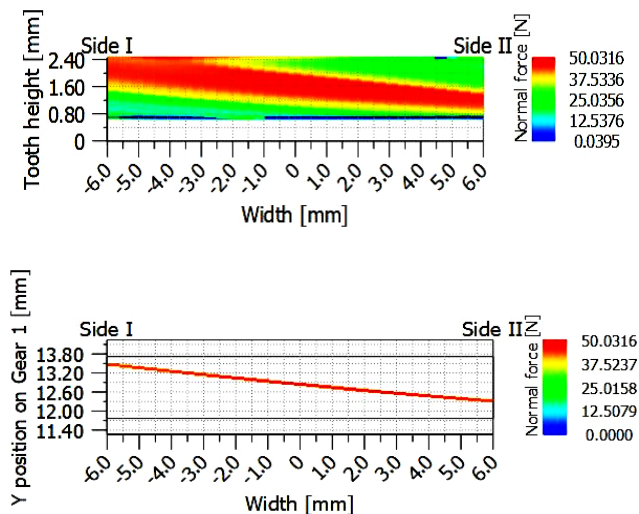
**Figure 17** Pinion Contact line diagram Pre modification

As per Figure 17 the loading pattern is starting from Side II and ending to Side I of the face width. The ends of face width are deflecting because of the cantilever load. Any lateral deflection in the tooth is deteriorating the contact pattern of gear set. This will damage the gear surface. To take care of this tooth surface is modified with crowning so that the load gets concentrated at centre as shown in post modification.

Figure 17 and Figure 18 shows the contact line difference in Pre and post modification version.

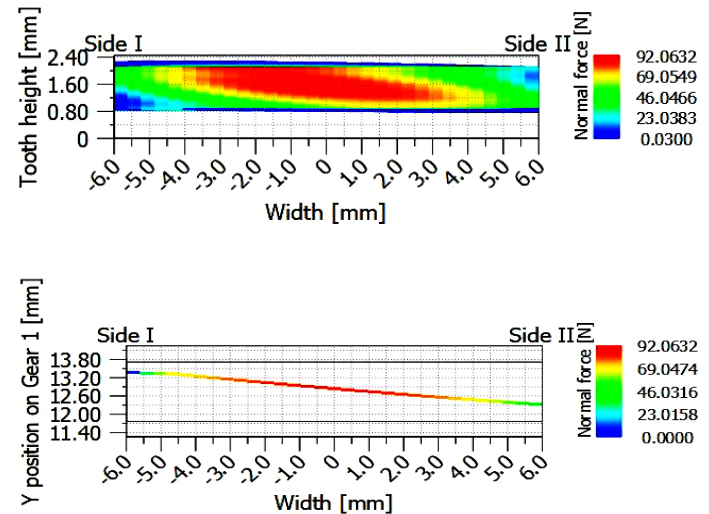
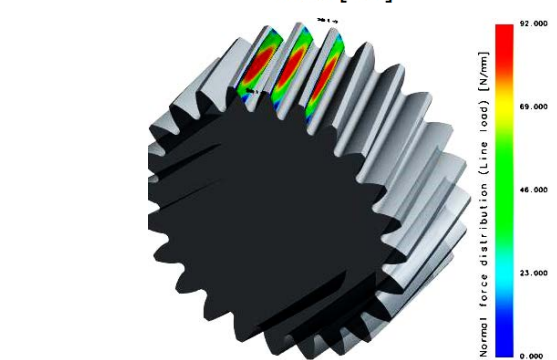
**Figure 18** Pinion contact line diagram Post modification

Crowning of teeth at centre provides the increase in the stiffness at centre of the teeth also. Parallely since the teeth profile is curved so the contact area is also reduced causing the high load concentration at centre of face width as shown in the Figure -18. Because of low contact area which is taking the complete load the

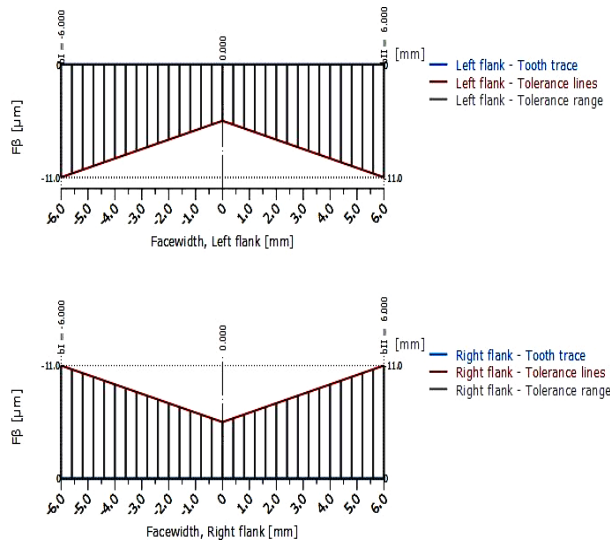
Figure 19 Contact Pattern pre modification

The above figure shows that there is no modification in the tooth form and the blue line along with red line shows the boundary limit. The grey line shows the tolerance range. This is purely defined as per the accuracy grade of the gears as defined. Manufacturing must be in between the red and blue line within tolerance zone.

Tooth trace diagram shows the tooth modification along the face width. Figure 19 and Figure 20 clearly shows the tooth modification of pre and post modification.

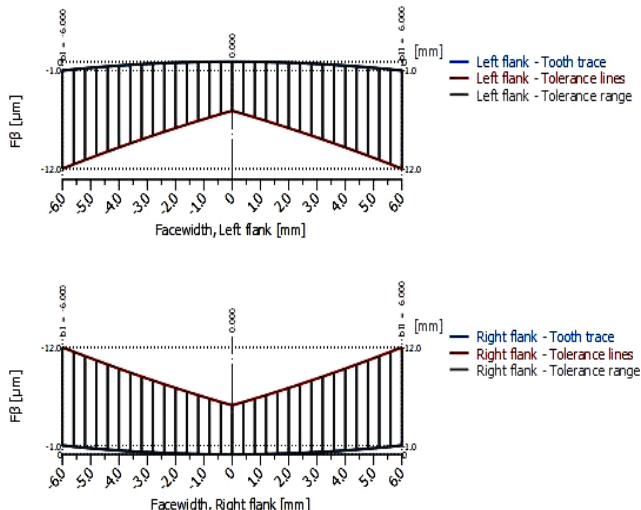
Figure 20 Contact Pattern post modification

The above figure shows that there is modification in the tooth form and the blue line along with red line shows the boundary limit. This is usually done for the mating flank but here it is done for both the flank. Also known as crowning effect help in increasing the stiffness of gear at mid of face width.

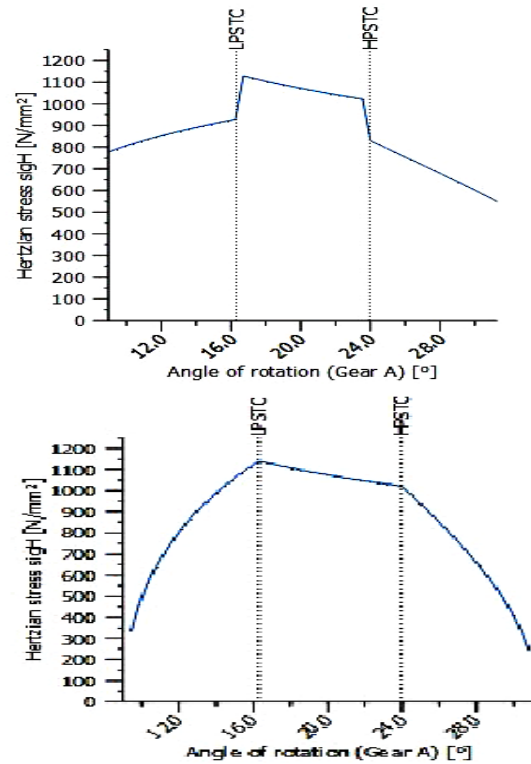
Figure 21 Hertzian stress distribution pre and post modification

As shown in the above figure the stress distribution over the contact line has changed to smooth curve from sharp peaks as shown in pre modified version. This help in gradual stress distribution over the contact zone helps in avoiding high stress concentration zone.

Figure 21 shows the Hertzian stress distribution pre and post modification on the gear pair contact line.

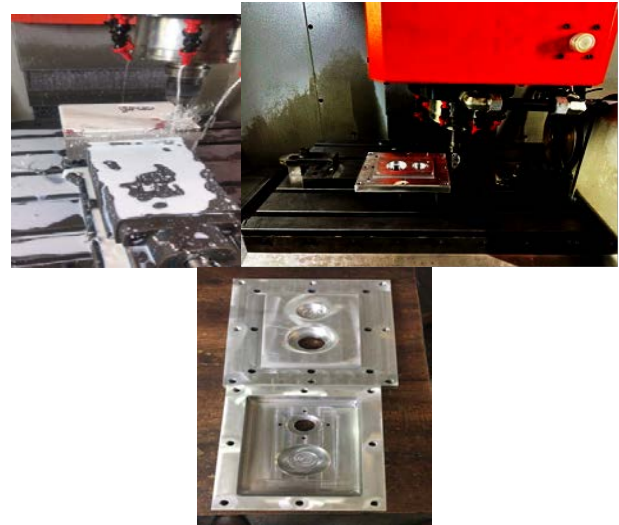
**Figure 23** Gear casing

Gear and Pinion was manufactured with 20MnCr5 material. Conventional hobing machine is used to cut the gear and later the grinding machine was used to provide the ground surface as per need after case hardening. Images while manufacturing is shown below in Figure 16. Bearings used in the assembly was 6006-2z and 61904-2z which are life long lubricated bearings and don't need external lubricants to work.

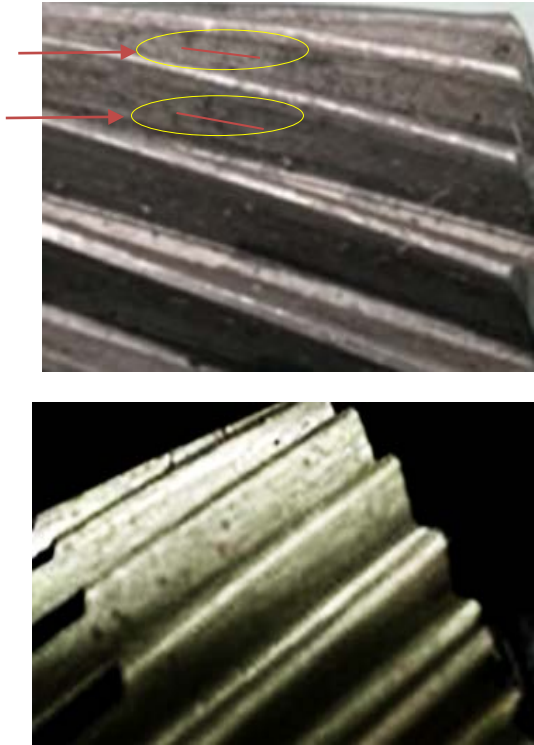
**Figure 26** Gear Surface snap pre and post modification

Experimentation was run for two sets one with gears without modification and other with modifications. After the testing the gears were cleaned, and their snaps were taken. The highlighted zone in the Figure shows the signs of micro pitting. The figure shown on the right-hand side shows no such changes on the flank surface for the same duty cycles. The micropitting was observed in Pinion only and that also in dedendum zone.
